BOW THRUSTER OVERHAUL

AMEL SM HULL # 335 by Gary Silver 5-1-2007 Reprinted by Bill Rouse s/v BeBe 3/1/10

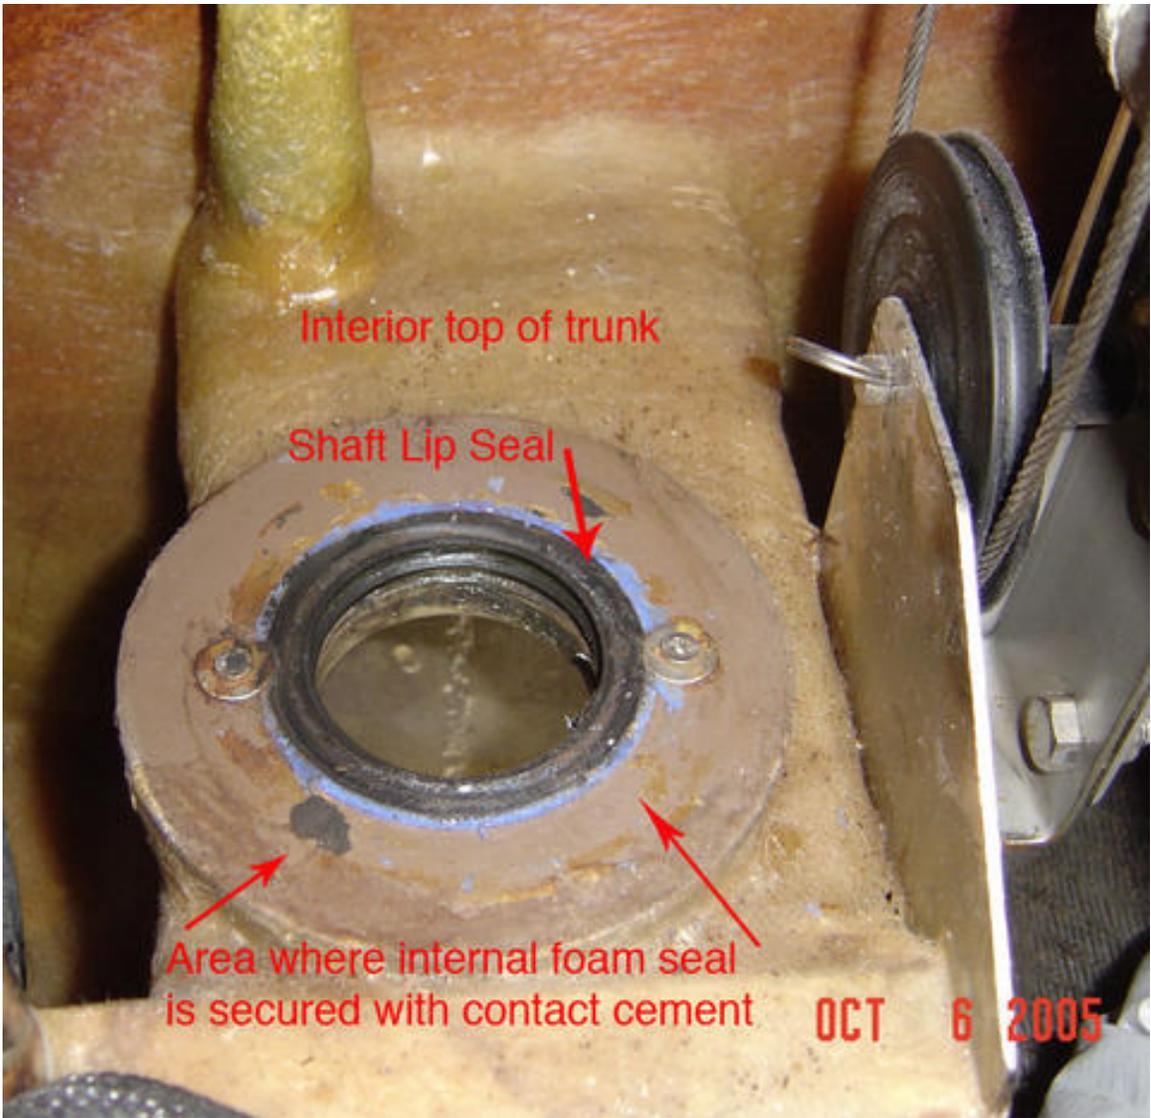
Interior top of trunk

Shaft Lip Seal

Area where internal foam seal
is secured with contact cement
